CASE STUDY:

CocoWalk Lifestyle Center

COOLING TOWER & CLOSED LOOP WATER TREATMENT

Project:	CocoWalk Lifestyle Center
Location:	Coconut Grove, FL
Scope of Work:	<ul style="list-style-type: none"> ▶ 2-Cell, 720 Ton Cooling Tower System ▶ Less Than 4000 Gallon Closed Loop
EasyWater Equipment:	<ul style="list-style-type: none"> ▶ CTF - Cooling Tower Treatment (Model CTF-100) ▶ Series C - Closed Loop Treatment (Model CLC-1000)

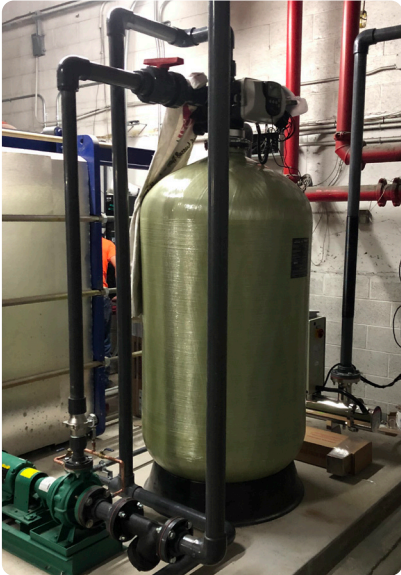
EasyWater CTF System:
Model CTF-100 Installation at CocoWalk

CocoWalk purchased (1) EasyWater CTF-100 Treatment System for the cooling tower and (1) EasyWater CLC-1000 to treat the closed loop heat pump system.

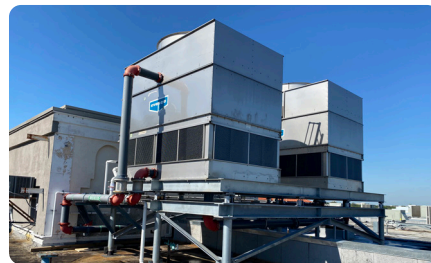
2 Cell Cooling Tower at CocoWalk

This facility has a cooling tower system and plate and frame heat exchangers providing water for a heat pump system. The equipment provides air conditioning for all tenants. Like many cooling towers, CocoWalk was plagued with ongoing problems from:

- ▶ Hard water scaling in there piping system and heat pumps
- ▶ High bacteria counts
- ▶ Hard water scaling in the cooling tower fill

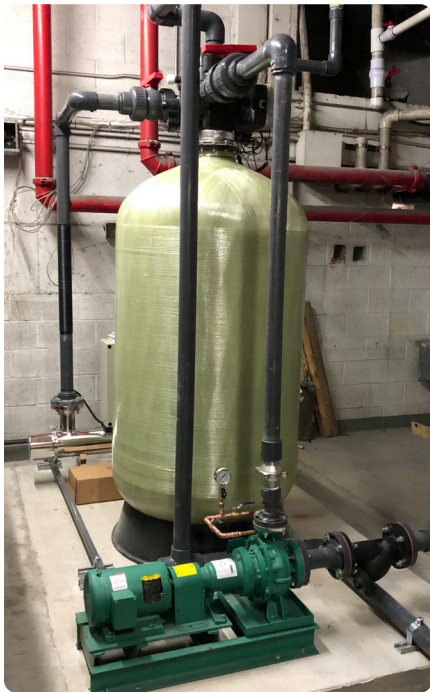
EasyWater SedimentShield Filtration for CTF-100

- ▶ EasyWater SedimentShield—a sub-micron, backwashing filter for the removal of sediment and bacteria
- ▶ Ultraviolet chamber for bacterial sanitization
- ▶ EasyWater No-Salt Conditioners to prevent and remove hard water scale deposits, biofilm, and bacteria. Our No-Salt Conditioners have the added benefit of preventing the hot UV lamps from scaling.

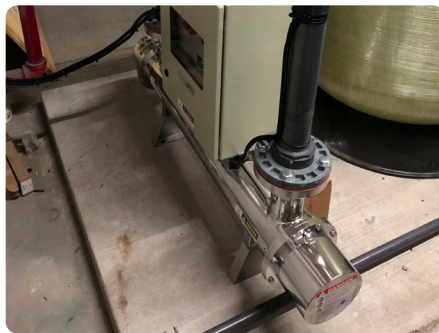
Ultraviolet (UV) for CTF-100

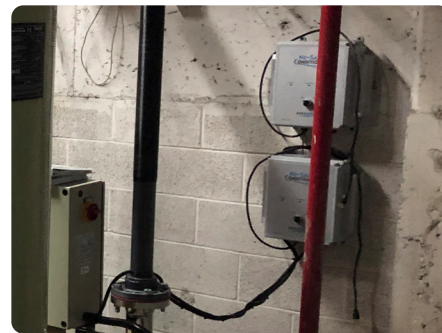
EasyWater No-Salt Conditioners for CTF-100

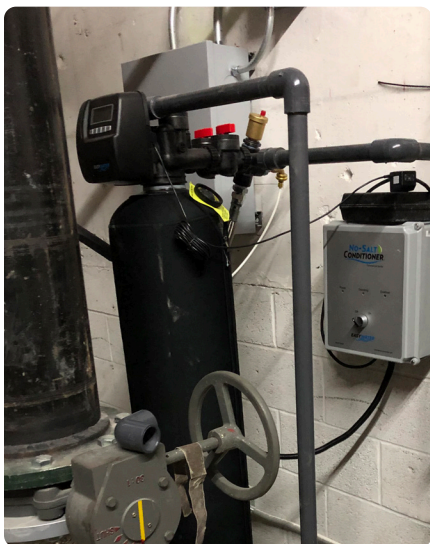
EasyWater Series C System:
Model CLC-1000 Installation at CocoWalk

EasyWater's Series C System is an advanced closed loop treatment system that eliminates the need for chemical treatment:

- ▶ Proprietary filtration media that continuously removes dissolved oxygen
- ▶ Sub-micron, self-backwashing filter for the removal of sediment, debris, and bacteria
- ▶ EasyWater No-Salt Conditioners to prevent and remove high iron content and hard water deposits.

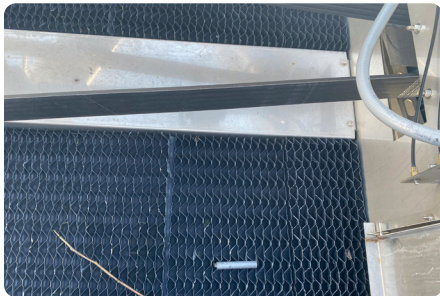
Top of cooling tower with no scale after (1) year

Our CTF Treatment System has continuously maintained low bacteria count, clear water, and no scale. A small amount of oxidizing biocide is used and properly maintained as a precautionary measure for Legionella.

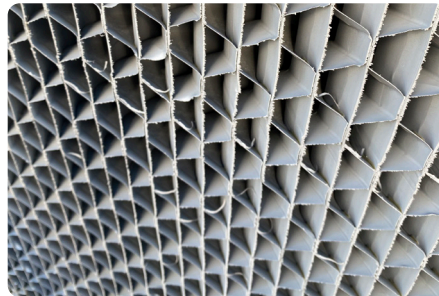
Side of cooling tower with no scale after (1) year

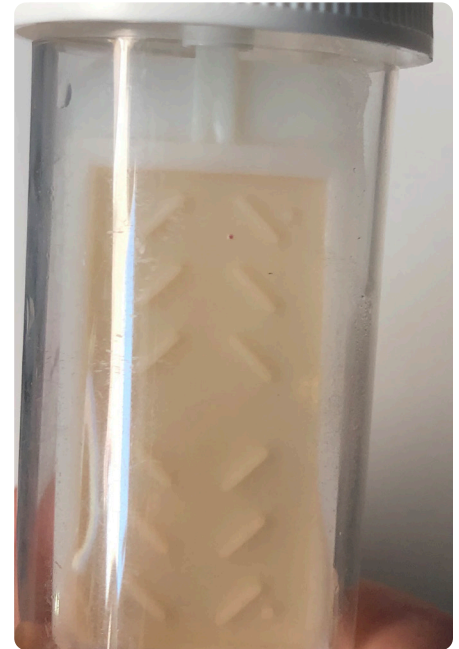
Bacteria dip slides continue to register 10⁰ on a monthly basis.

Bacteria Dip Slide Results:
10⁰

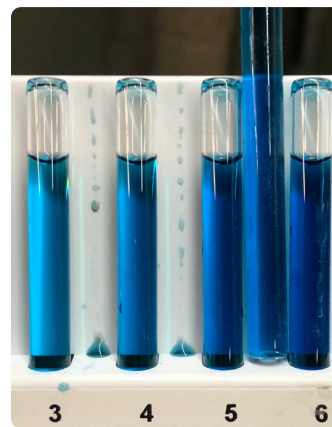
Before - Dissolved oxygen test results 5-6ppm

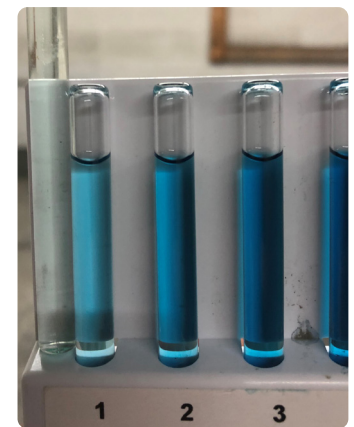
After 8 Months - Dissolved oxygen maintained at <1ppm

Dissolved Oxygen Content:
<1 ppm
