# CASE STUDY: Large Private Arizona Facility

## TREATMENT OF HIGHLY CORRODED CHILLED & HOT WATER CLOSED LOOPS

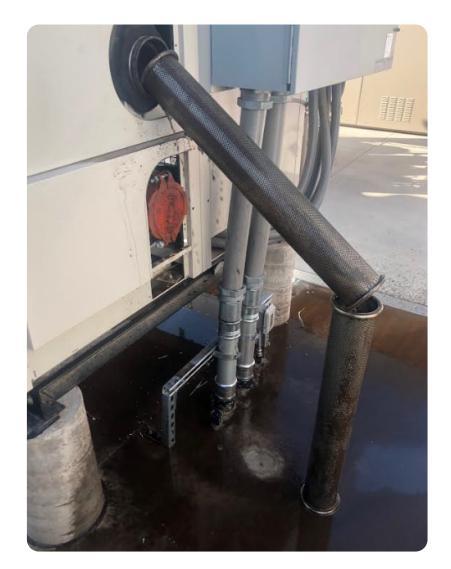
Debris shown in chiller strainers

The closed loop systems ran without water treatment for about 9 months. The top two pictures on the left are the strainers in the chiller that were pulled in May of 2022. In an attempt to solve the problem, they ran detergent through the system which resulted in additional rust and debris plugging the strainers.

EasyWater Series C - Model CLG-1000 Component System In February 2023, EasyWater shipped (2) Series C - Model CLG-1000 Component Systems. These systems are made up of 3 main components:

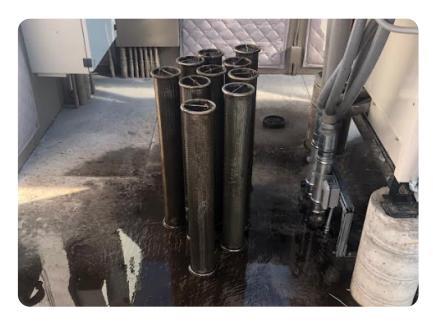
Plugged up mesh strainers from closed loop system

The problems were discovered when they started plugging 30 mesh strainers in their closed loops. A 60 mesh y-strainer was also installed, which became a maintenance nightmare because it plugged twice a day. They began looking for a treatment system that would minimize corrosion and stop producing the black metal debris. They also needed a filtration system that would filter to less than 1 micron and clean the systems.

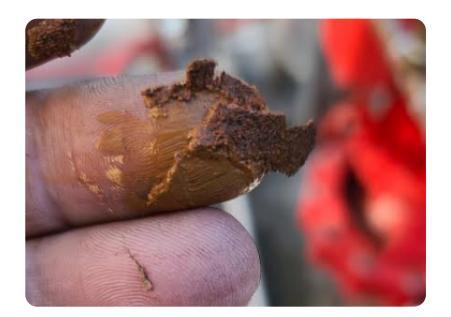
Close up of the rust and and debris in the chiller

Lab reports confirmed that they had corrosion issues caused by dissolved oxygen as well as high iron content deposits in their closed loop chilled and hot water systems.

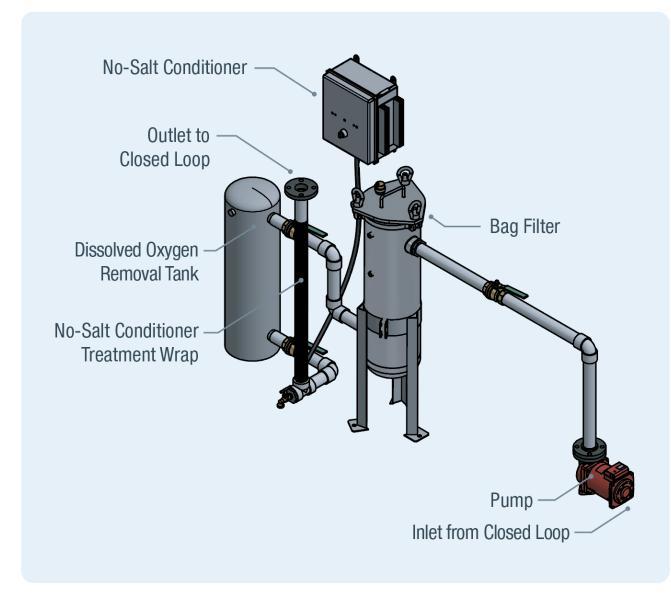
#### 1) Dissolved Oxygen Removal Media:

#### 2) No-Salt Conditioner:

#### 3) SedimentShield Sub-Micron Filtration:
